## Lake Lure Dam

Independent Consultant  
Dam Safety Inspection  
*November 2006*

Town of Lake Lure  
North Carolina

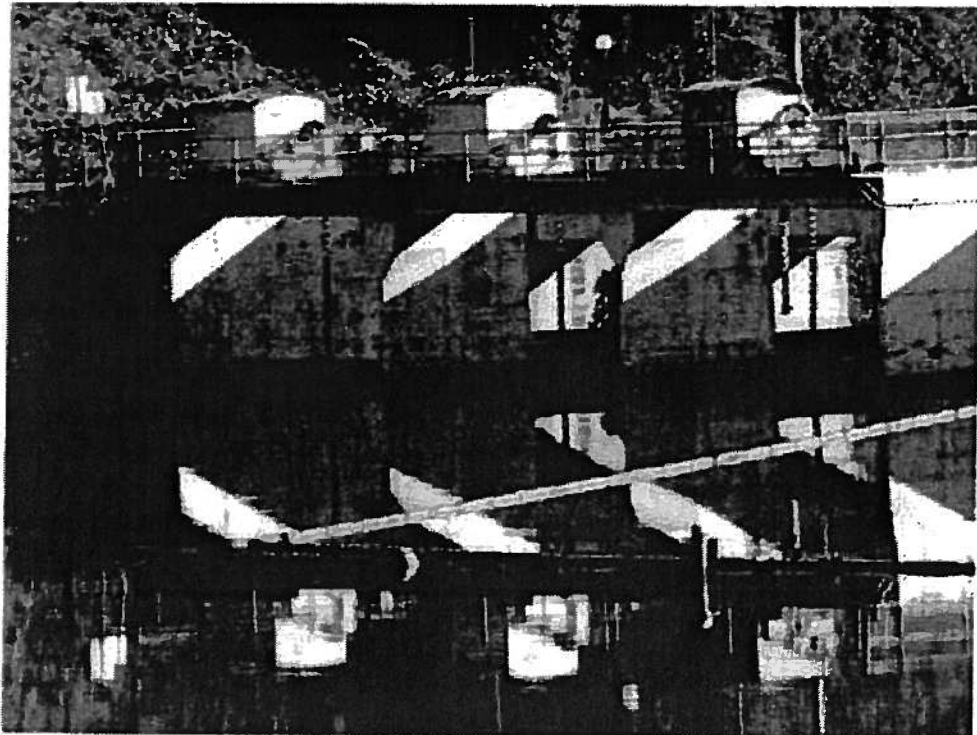
**Photograph 2 Spillway Gates**

The three steel frame radial gates (Photographs 2,6 and7) are in good condition and reported to operate well. Maintenance, including new seals was performed in the mid 1980's. The gates are operated to prevent the elevation of Lake Lure from rising significantly above full pond and to route significant storm events. Each gate has a dedicated hoist with a single lift chain which connects/wye's to cables attached to each side of the base of the gate. The coating of the gates is in good condition. Leakage was occurring, but was not excessive and seemed concentrated at the gate corner where the bottom and side seals intersect. This is a common location for some leakage to occur in this type gate. Some vegetation is growing on steel cross members and should be removed to protect the coating system and facilitate observation.

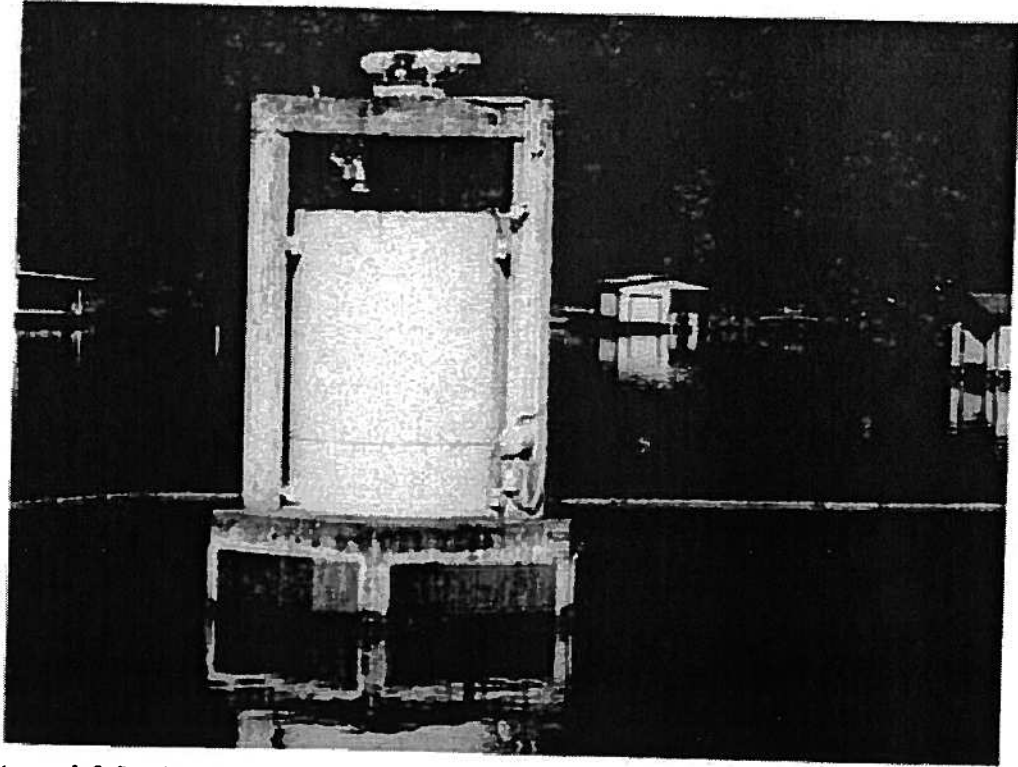
**Photograph 3 Intake and Cylinder Gate**

The intake to the hydroelectric station (Photograph 3) is a vertical concrete tower with a steel cylinder gate. The intake was observed from the bridge deck. No evidence of structural distress was observed. The cylinder gate is not normally operated and there was reportedly difficulty opening it the last time it was closed. The gate reportedly could be closed in an emergency.

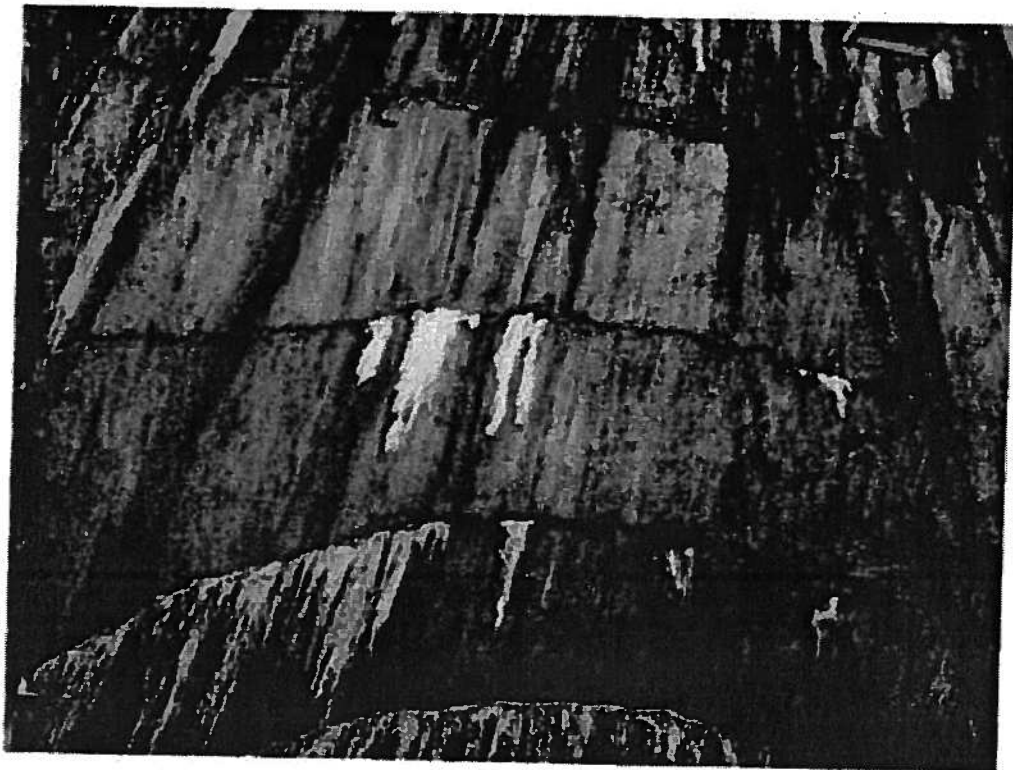
Arch bays located to the right of the powerhouse were inspected by entering each bay from the downstream side. Minor leakage and efflorescence was observed at the lift lines (horizontal boundaries between successive concrete pours) and at the base of the arch. Reportedly, leakage does not vary significantly with seasonal changes in air and water temperature. Portions of the arch concrete was obscured by vegetation (Photograph 15) and the arch bays located to the left of the powerhouse could only be observed from the bridge deck, left abutment slope and from a significant distance downstream. There were no observed instances of structural distress such as severe cracking, deformation or misalignment. Cracking is present at the top of the arch/buttness interface (Photograph 5). At a number of locations, spalled concrete is exposing steel that may be reinforcing steel as well as additional steel associated with supporting original formwork.

**Photograph 10 Efflorescence at Lift Joints**

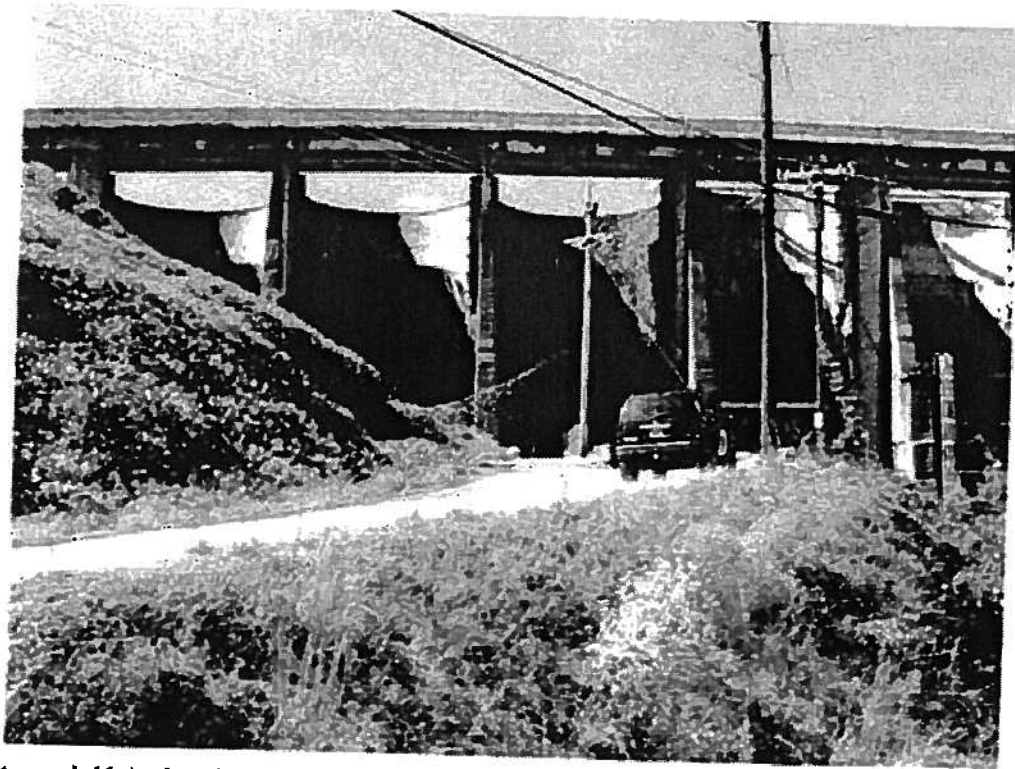
**Photograph 11 Arch and Buttress Sections**

The abutments were covered in very dense vegetation, mostly kudzu (Photographs 11, 12 and 13). There was no evidence of serious erosion or significant seepage at either abutment. The retaining wall along the left (facing downstream) abutment appears in good condition with no evidence of misalignment or other structural defects.

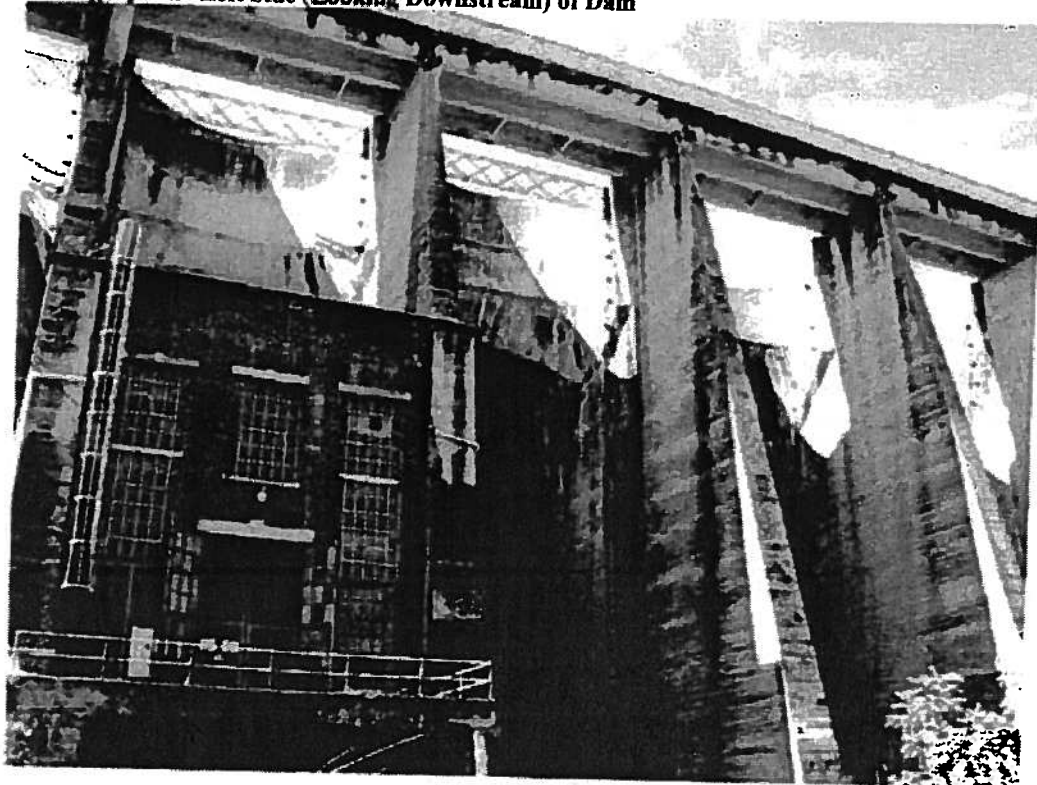
**Photograph 14** Powerhouse

The powerhouse (Photograph 14) is a concrete and brick masonry structure. It is in good condition for its age and both generating units are operable. The powerhouse is structurally independent from the dam.

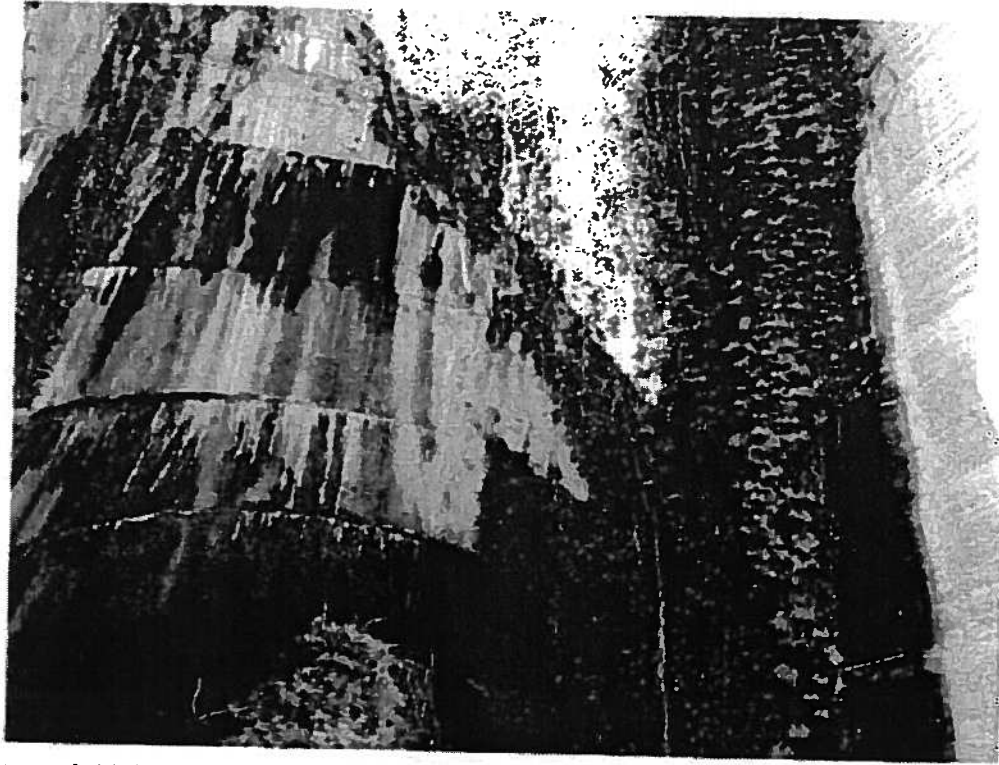
**Photograph 15** Vegetation Obscuring Concrete

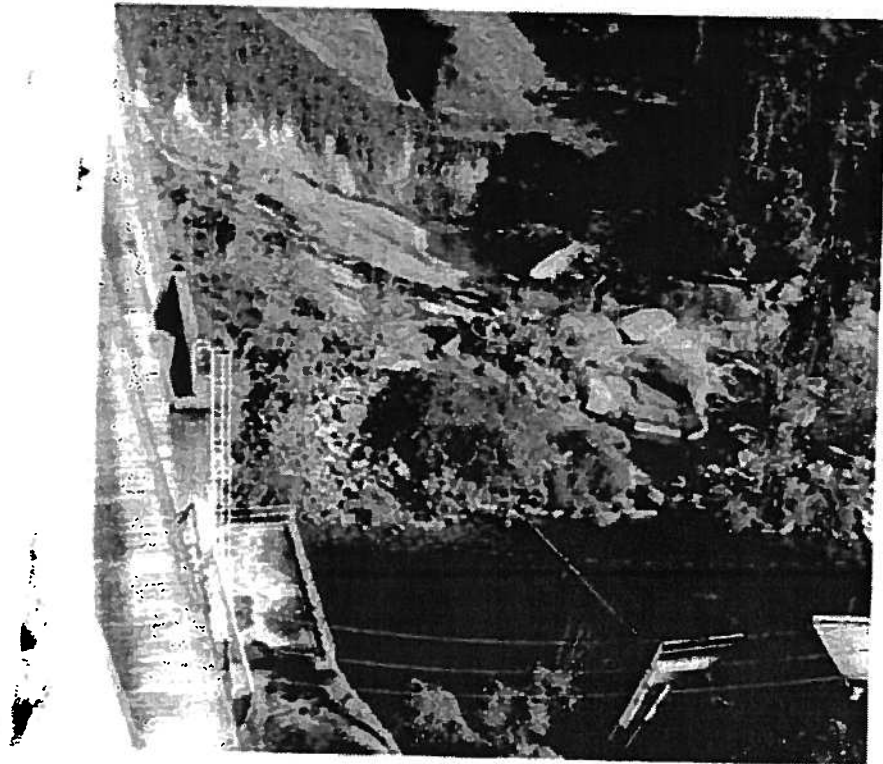
**Photograph 16** Area Without Safe Access

4. Retain a qualified dam safety engineering consultant to conduct a comprehensive visual inspection in two years (by 31DEC08). This inspection should include close examination of all arch bays including those to the left (looking downstream) side of the powerhouse and areas currently obscured by vegetation. If concrete deterioration has advance in extent and depth or if significant areas are present where reinforcing steel is exposed, concrete repairs should be considered at that time. If no progression in concrete condition is noted, similar independent consultant inspections from that point should be conducted at five year intervals.
