## MEMORANDUM

| <b>COMPANY:</b> | Town of Lake Lure | <b>SUBJECT:</b> | Lake Lure Dam Hurricane Helene<br>Preliminary Summary |
| <b>ADDRESS:</b> | 2948 Memorial Hwy<br>Lake Lure, NC 28746 | <b>PROJECT<br/>NAME/NO.:</b> | Lake Lure Dam / 18C21024.060 |

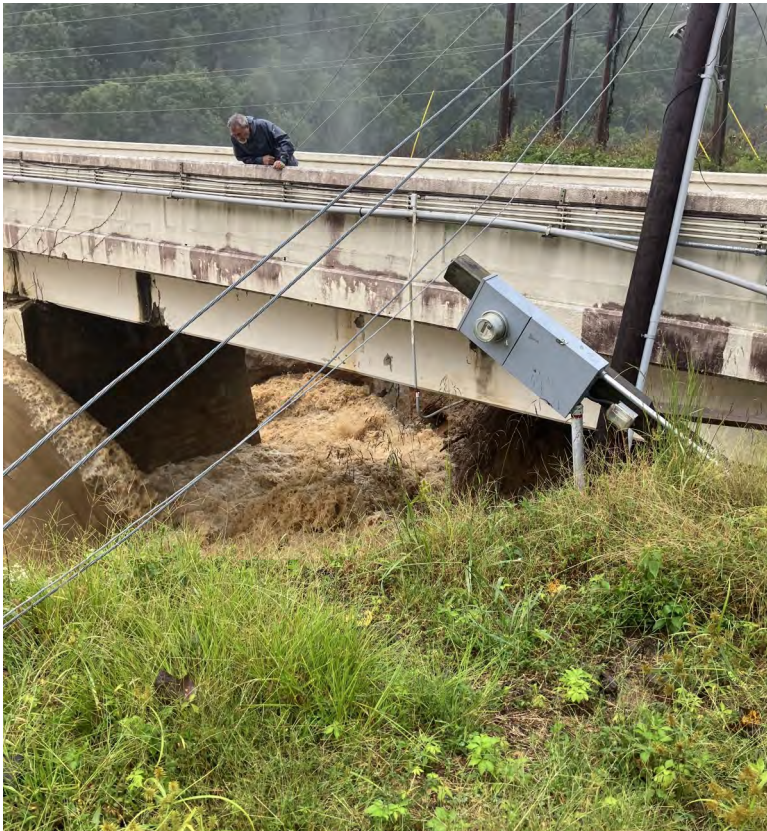
**Photograph: 2.1**

Arch overtopping and eroding soil downstream of concrete dam

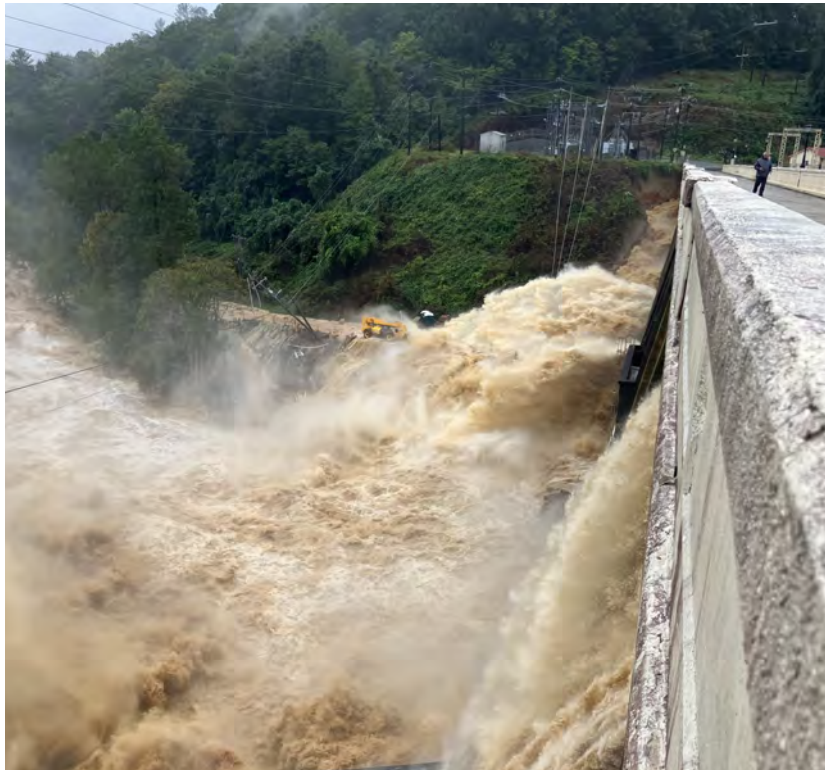
**Photograph: 2.2**

Low and mid level stage arches (all arches except Bays 6 through 8) overtopping and scouring downstream soils

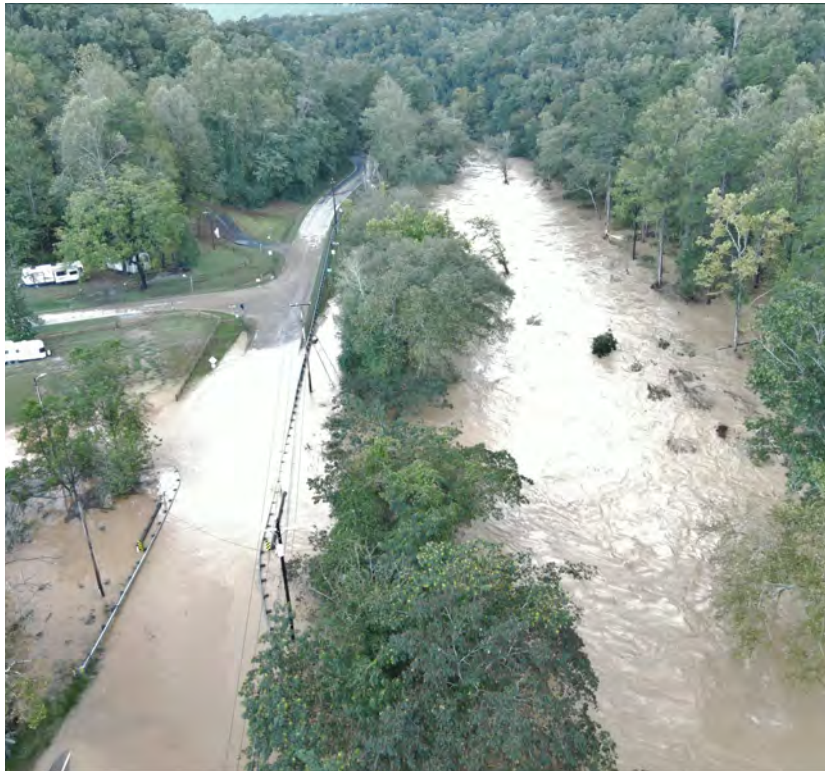
**Photograph: 2.3**

Broad River (right), (flooded road center), Island Creek (left)

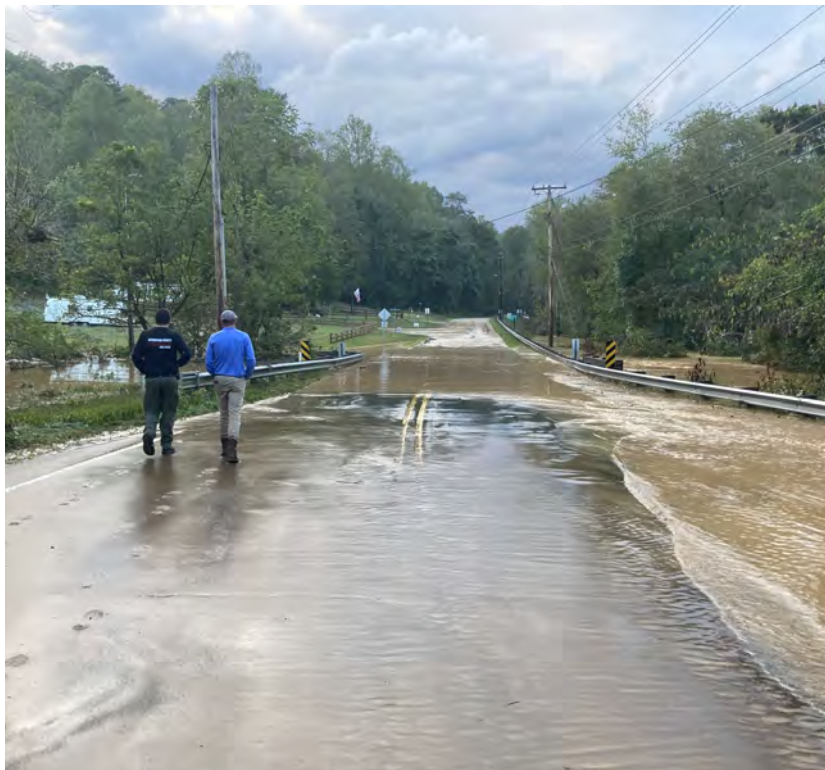
**Photograph: 2.4**

US Route 74 flooded at Island Creek

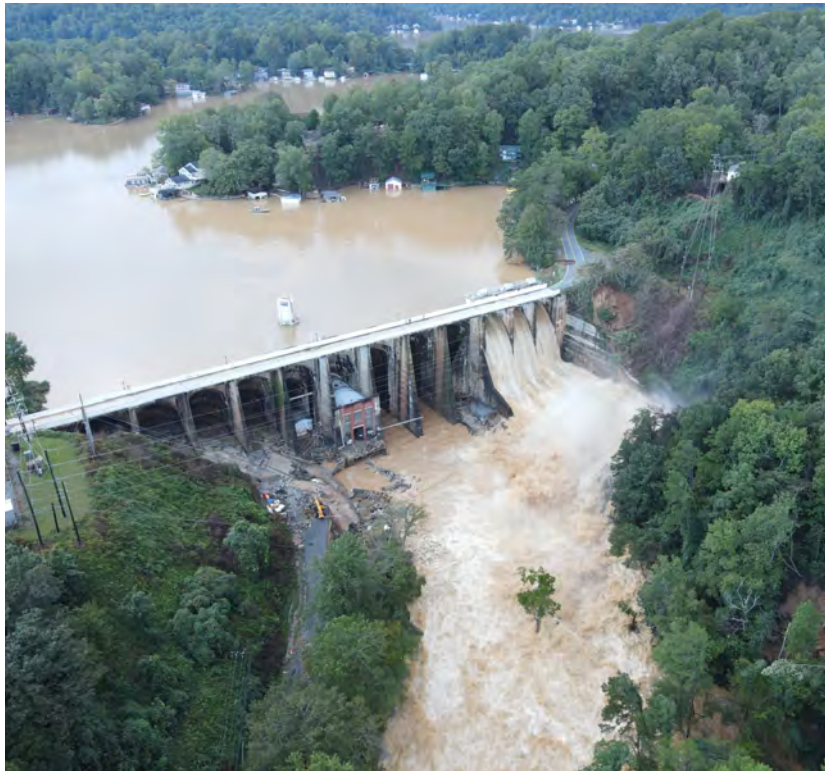
**Photograph: 2.5**

Downstream flooding. Gates open approximately 8 feet each.

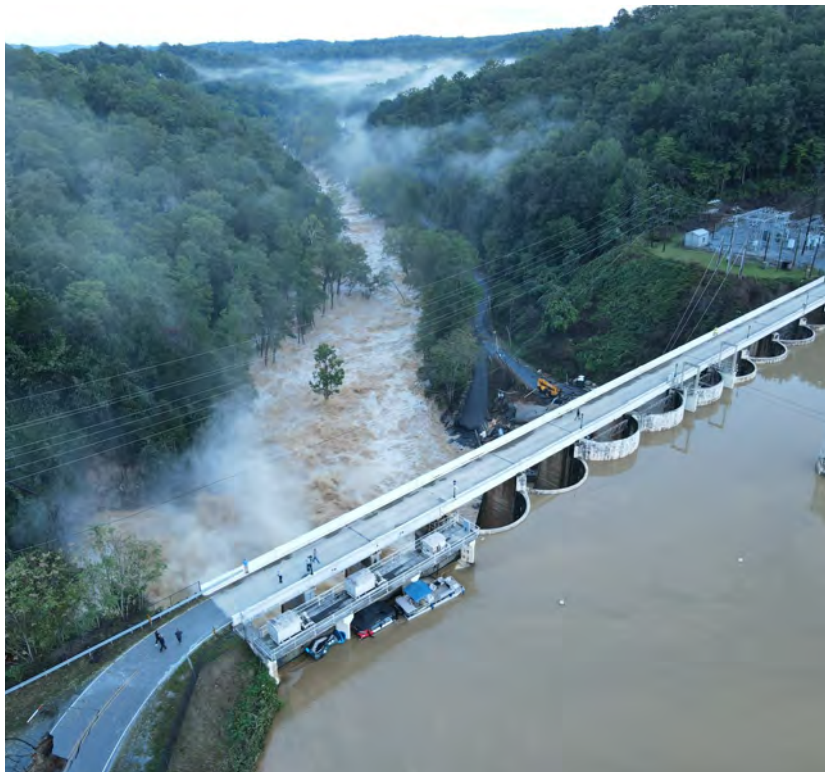
**Photograph: 2.6**

Downstream flooding. No flow over the arches.

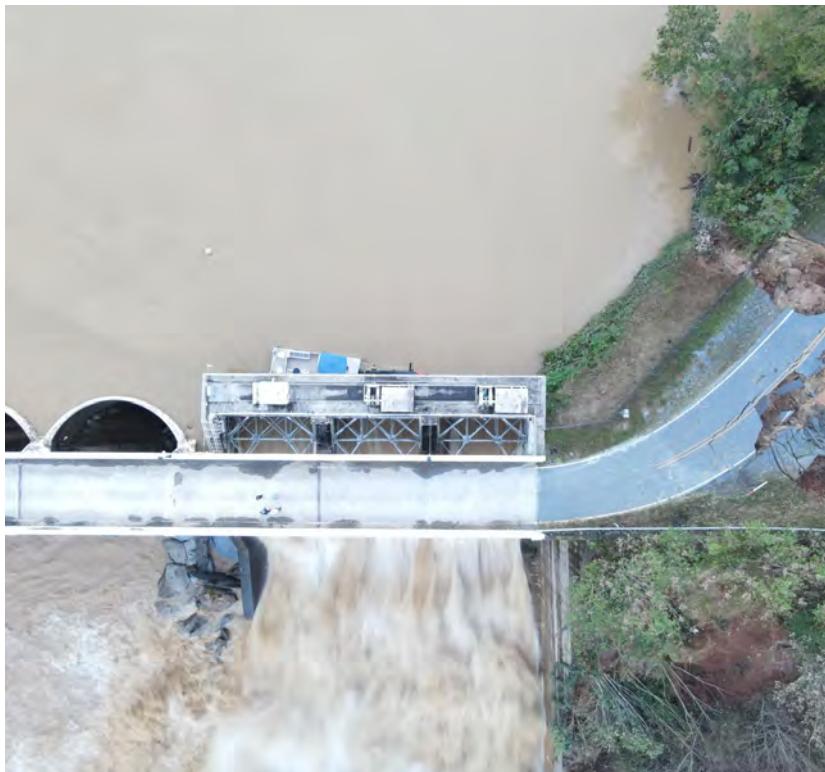
**Photograph: 2.8**

Note the damage to the upstream slope and the roadway surface, and the downstream slope failure on the downstream slope, behind the left spillway sidewall.

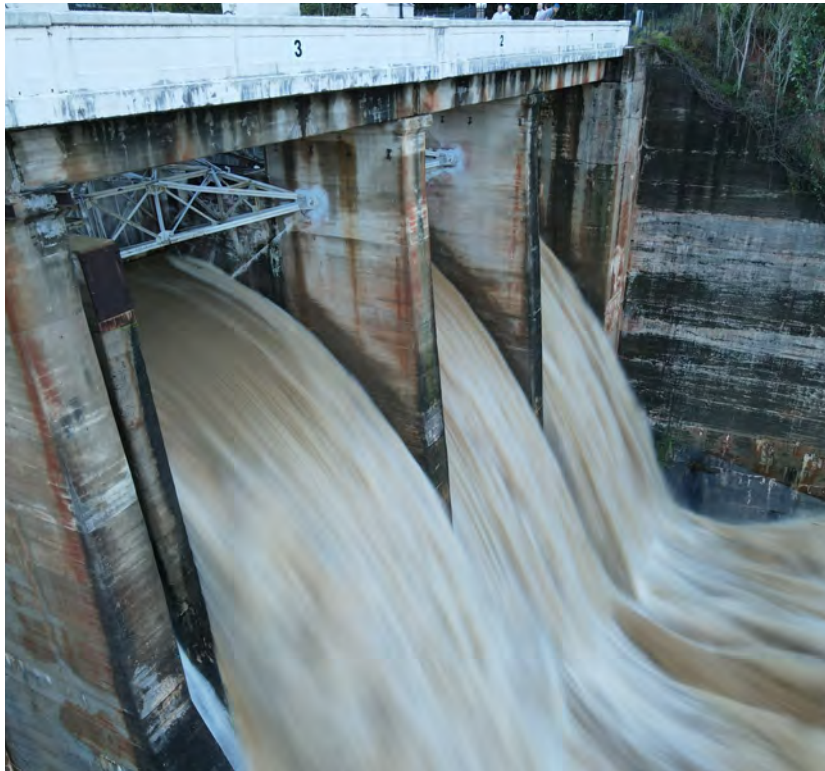
**Photograph: 2.9**

Tainter gates open approximately 8 feet each.

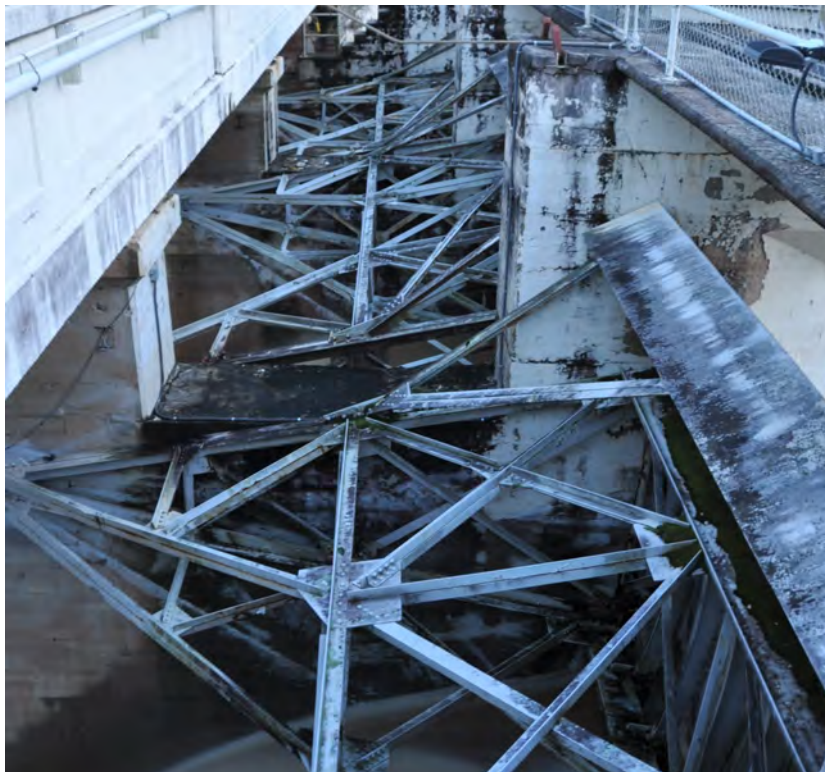
**Photograph: 2.10**

Tainter gates open approximately 8 feet each.

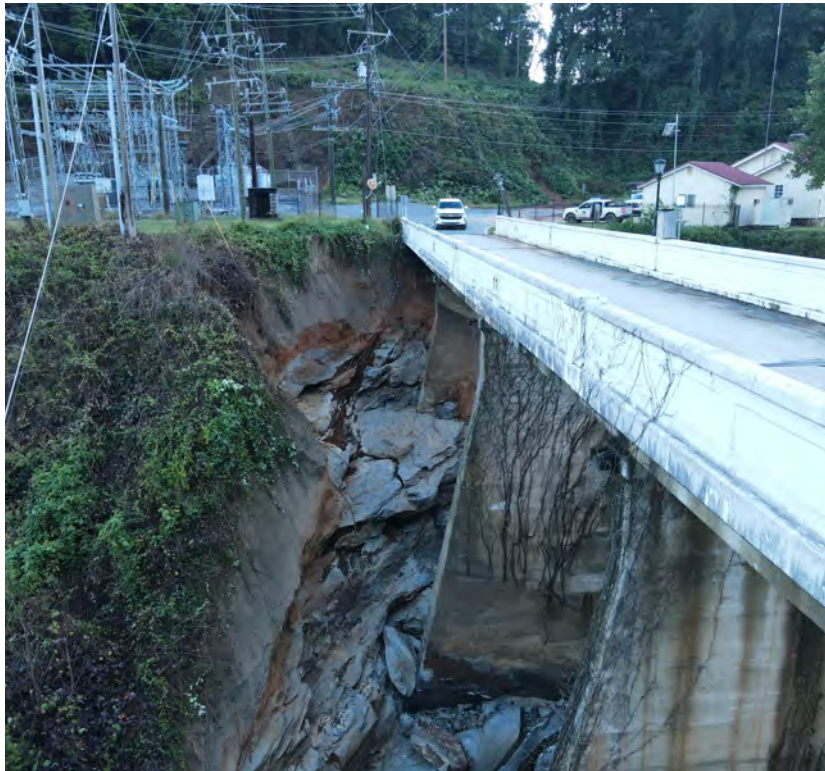
**Photograph: 2.11**

Erosion from flow over arches. Exposed rock visible.

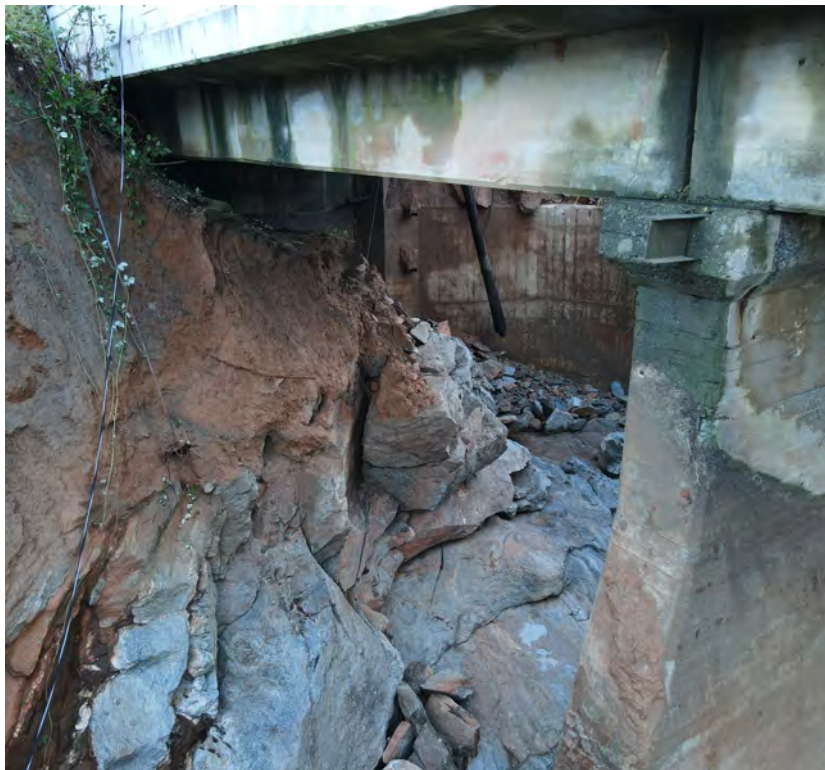
**Photograph: 2.12**

Erosion from flow over arches. Exposed rock visible.

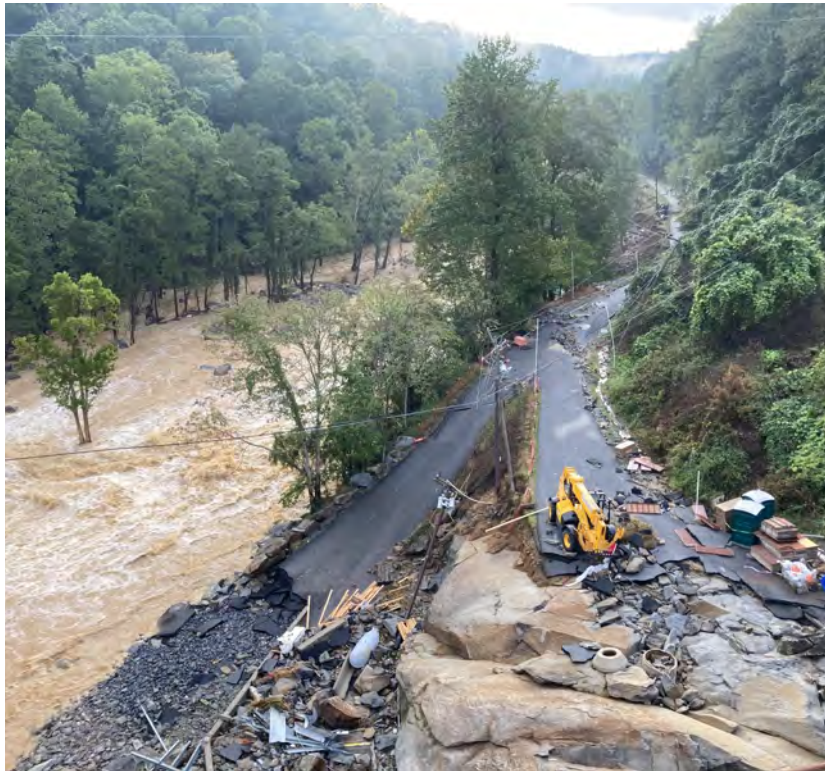
**Photograph: 2.13**

Damaged access roads, damaged construction staging area. Exposed rock from scour erosion.

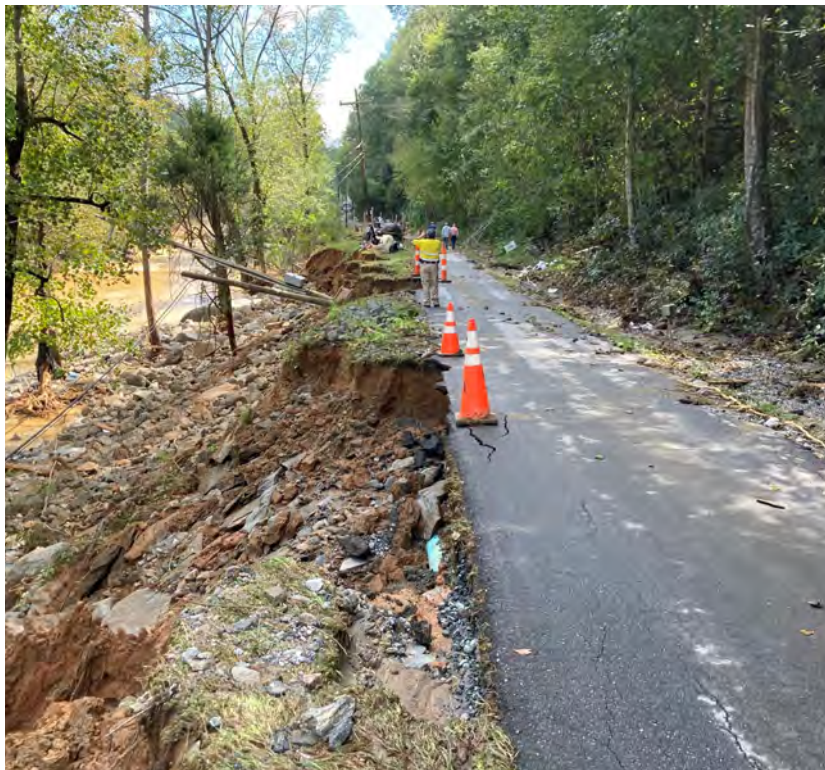
**Photograph: 2.14**

Damage to river bank and access road.

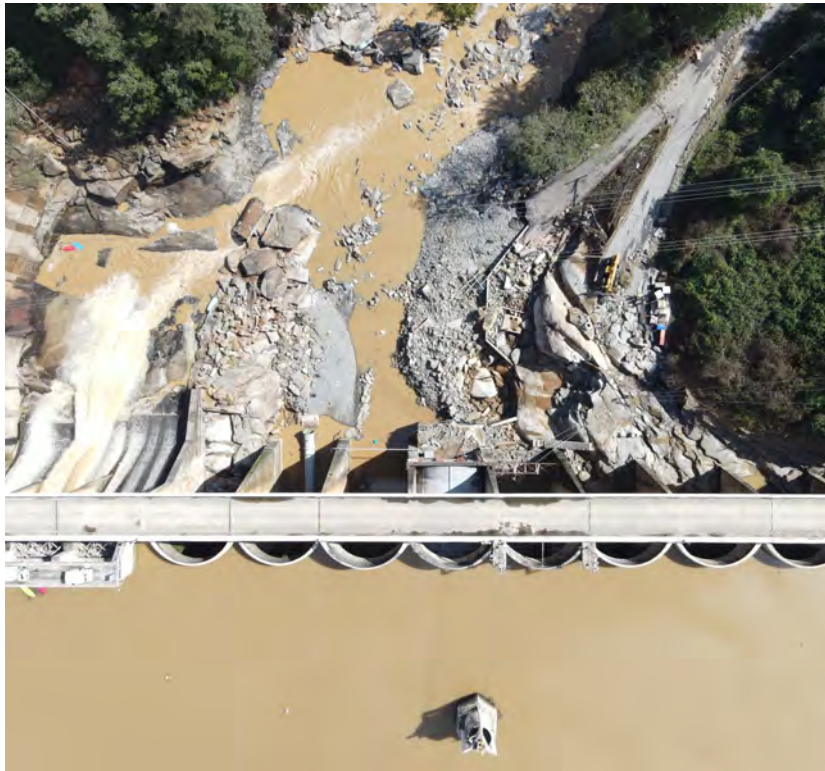
**Photograph: 2.15**

Gates partially closed - debris beneath gates. Note the damage to the access roads, evidence of scour erosion, exposed bedrock, demolished sewer lift station, demolished river crossing.

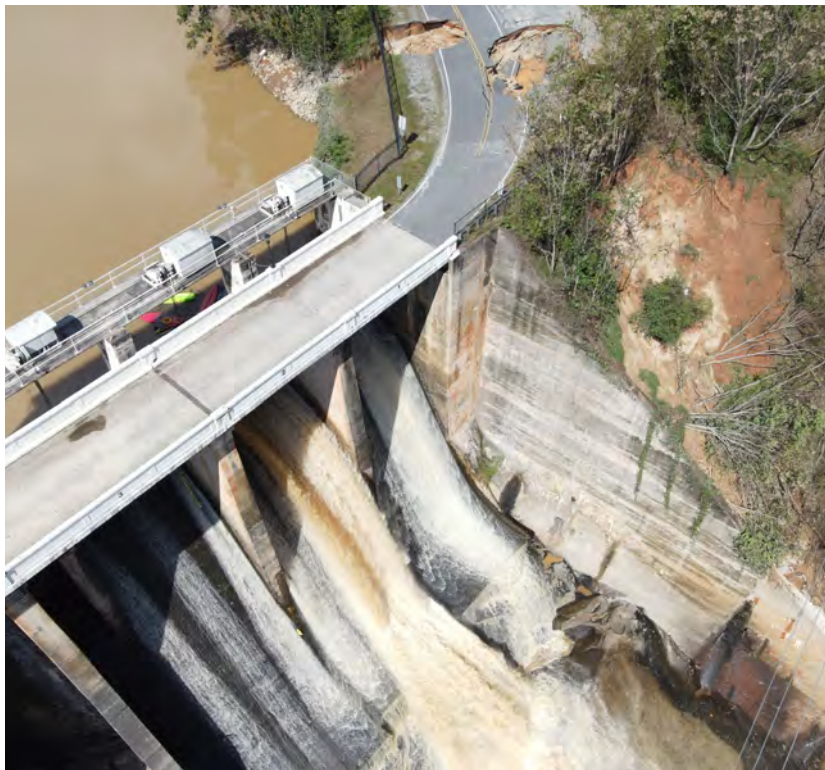
**Photograph: 2.16**

Gates partially closed - debris beneath gates. Note the damage to the upstream slope and roadway surface on the left abutment, and the slope failure on the downstream slope.

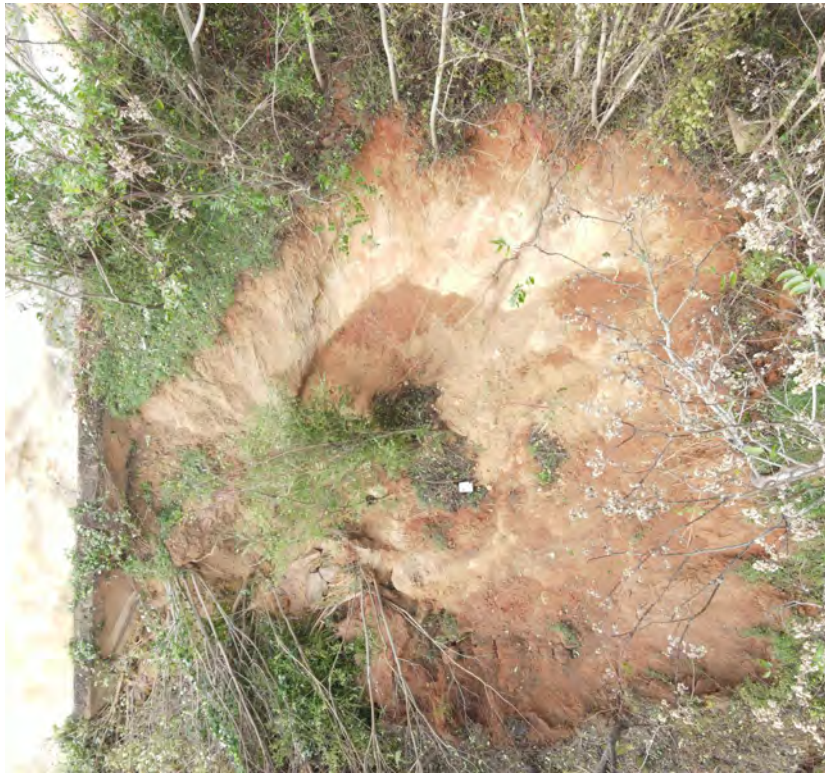
**Photograph: 2.17**

Slide visually estimated to be approximately 30 feet wide

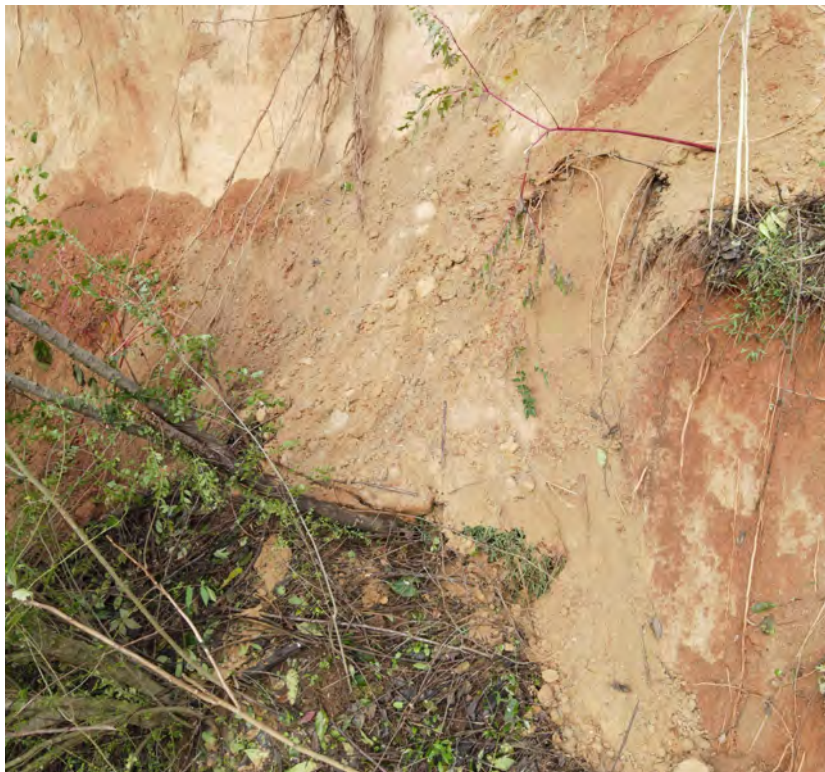
**Photograph: 2.18**

Upper portion of slide with near horizontal separation at change from possible topsoil collapse into void. Exposed slope is near vertical above the reddish colored material.

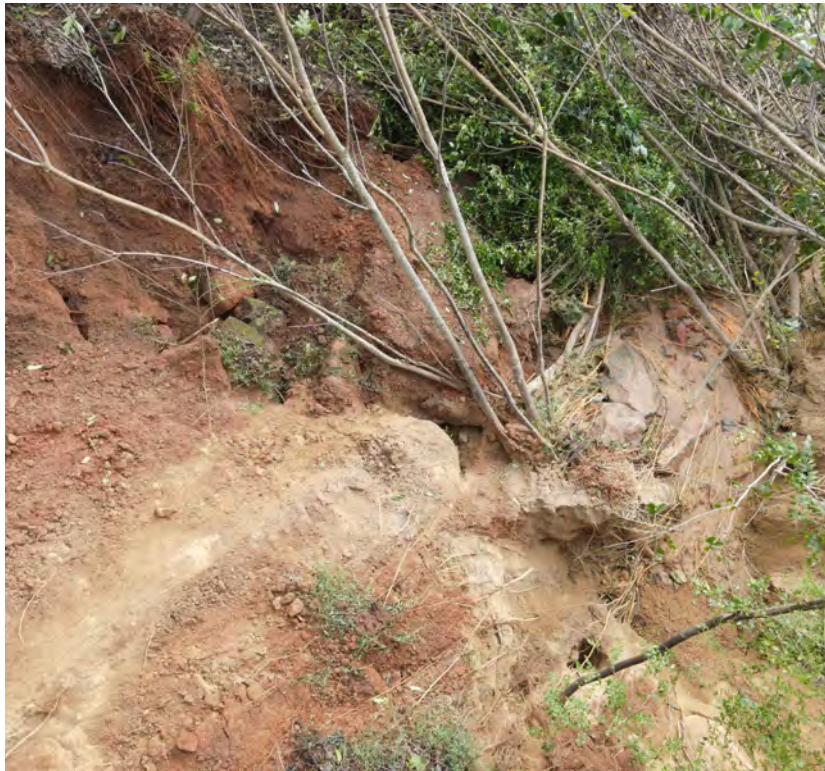
**Photograph: 2.19**

Close-up view of bottom of slide near bottom with some rocks observed with soil

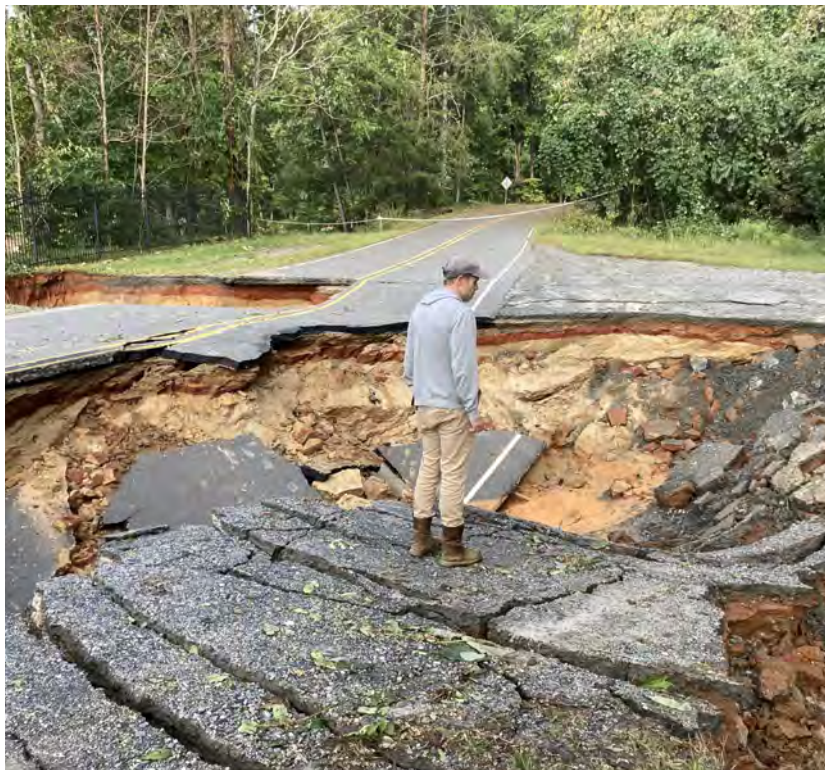
**Photograph: 2.20**

Damage to Buffalo Shoals Road.

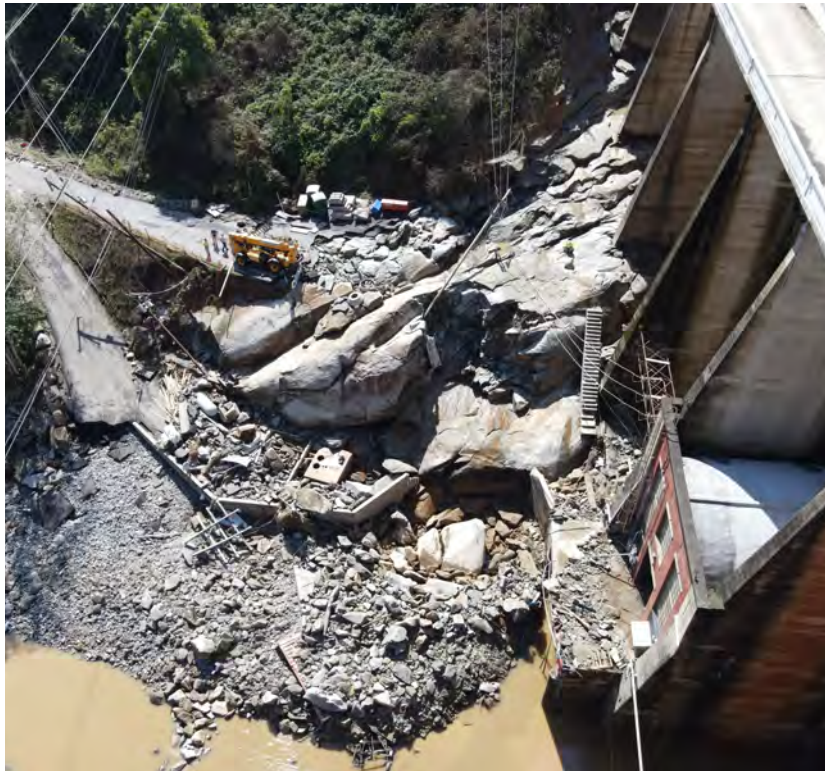
**Photograph: 2.21**

Overview of the right, downstream area. Note the damage to the access roads, scour erosion, exposed bedrock, damaged powerhouse, demolished sewer lift station, demolished river crossing.

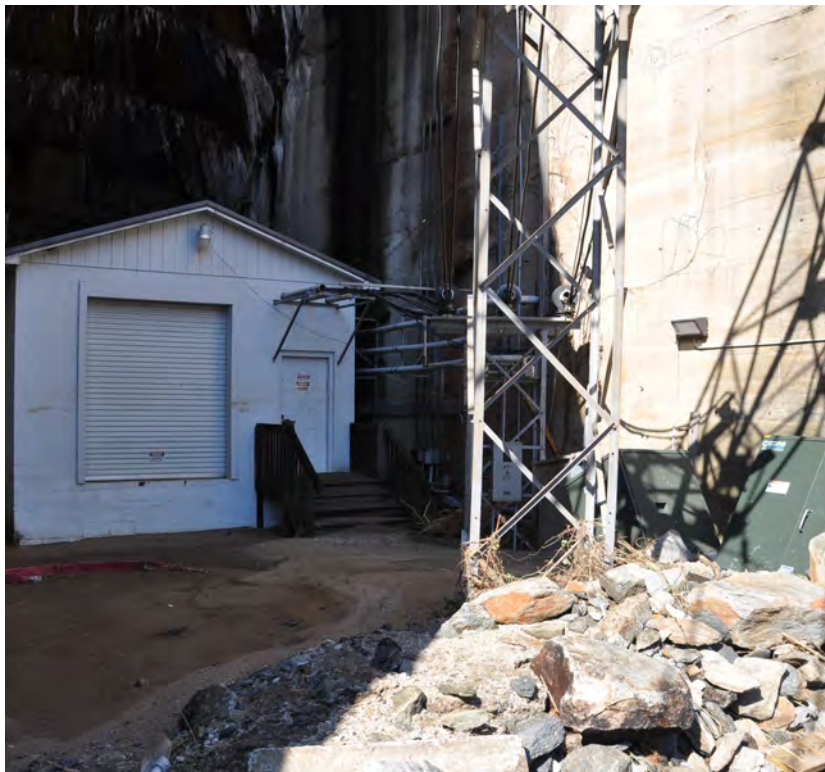
**Photograph: 2.24**

Sediment and rock deposited in front of structure. Displaced electrical boxes (green, right)

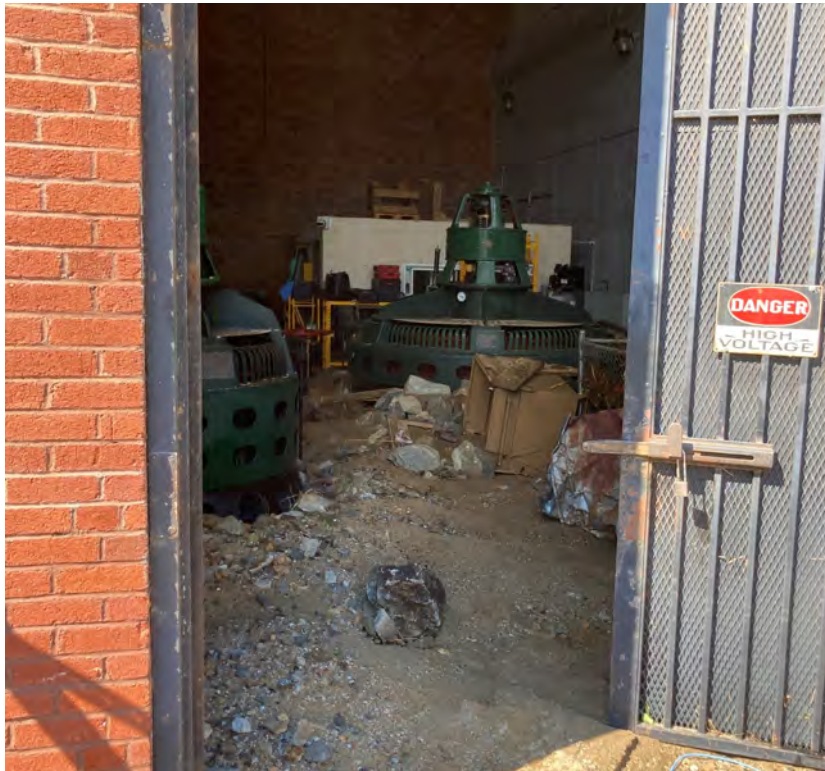
**Photograph: 2.25**

Sediment and rock deposited inside the powerhouse.

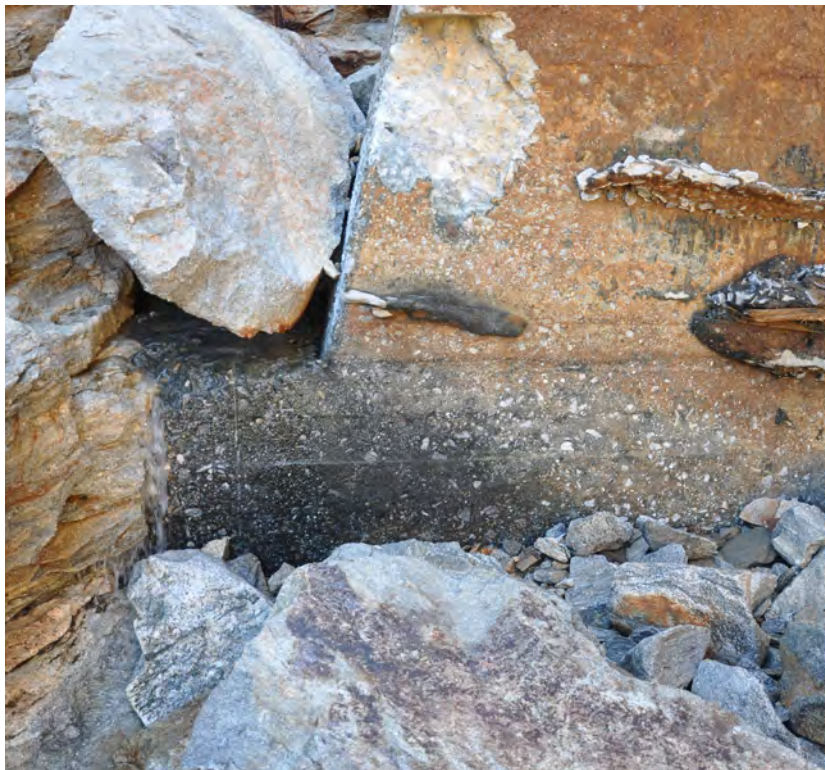
**Photograph: 2.26**

Soil eroded to contact where concrete buttress and overpoured to appear to bear on bedrock.

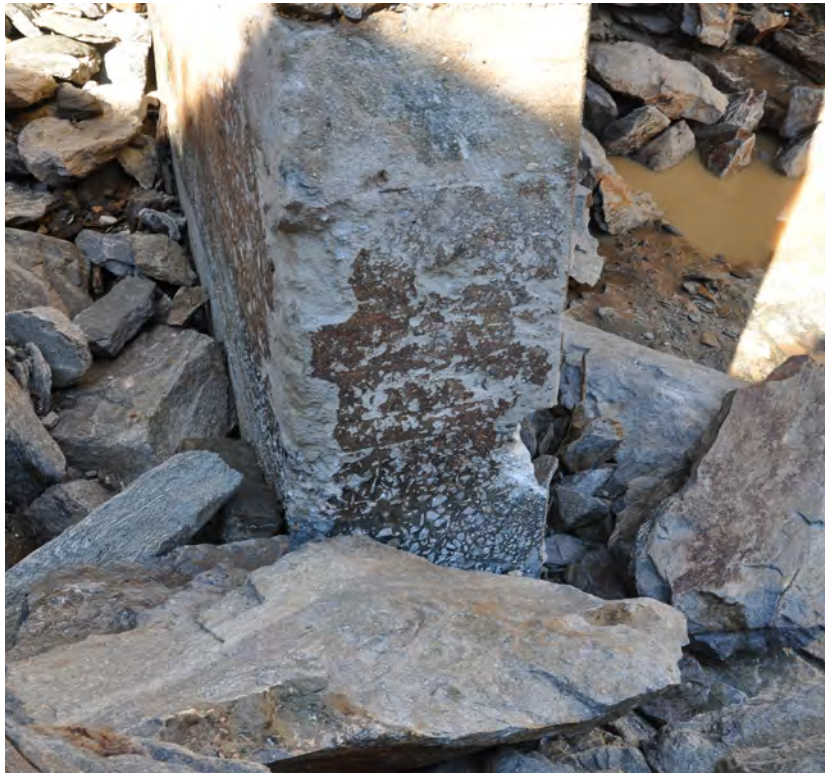
**Photograph: 2.27**

Spall approximately 6 inches deep  
maximum at corner. Soil backfill  
was eroded around buttress, but  
concrete appeared to be placed  
against rock.

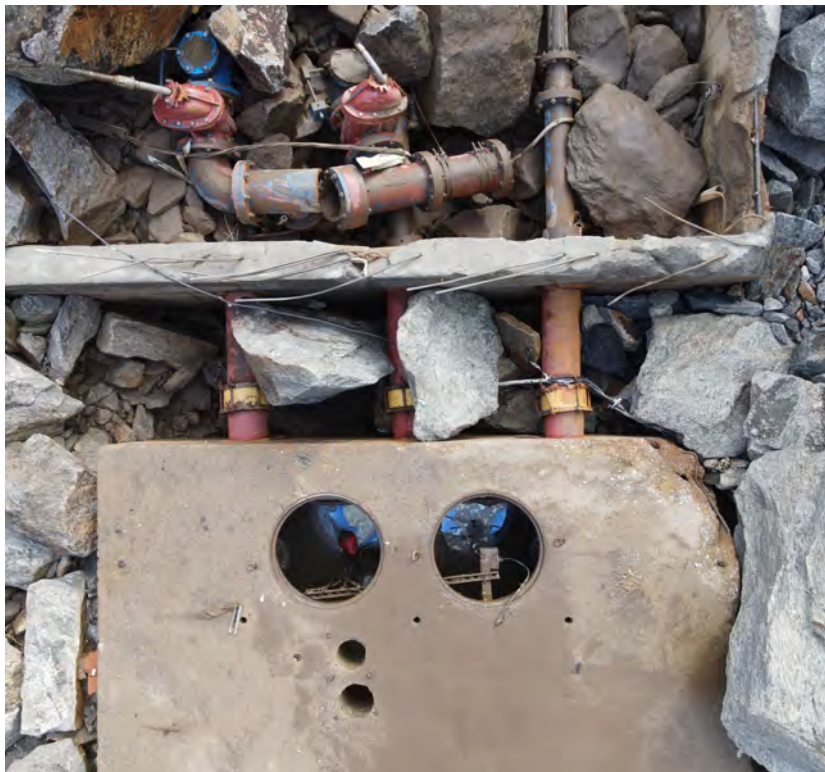
**Photograph: 2.28**

Remnants of the sanitary sewer lift  
station structure and piping.

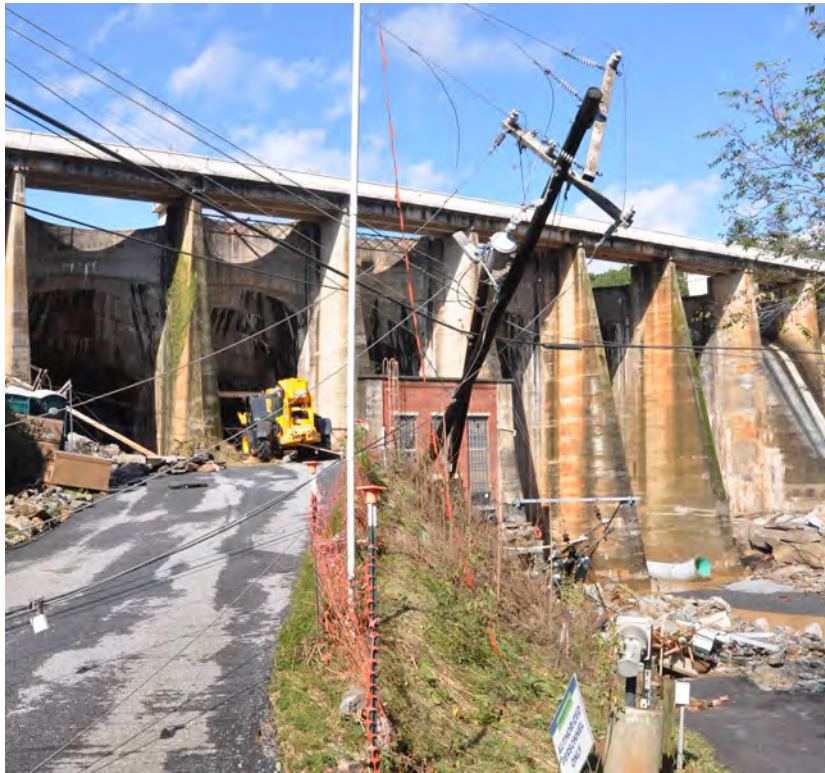
**Photograph: 2.29**

Damaged power poles. Debris on access roads.

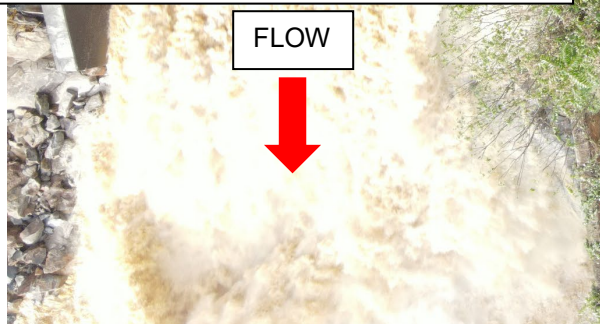
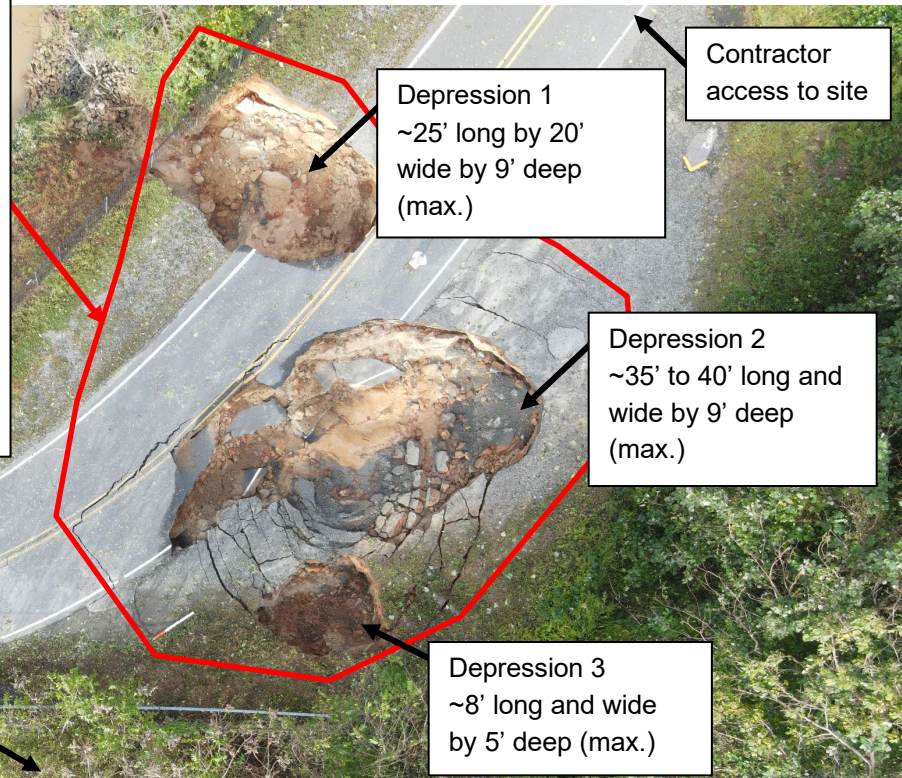
Figure 1. Photo Markup of Recommended Emergency Repairs to Left Abutment (Not to Scale)

1. Downstream slope at slide is very steep, near vertical at top. Contractor to avoid disturbing slope with equipment or personnel.
2. Perform work under fulltime observation of Schnabel Engineering South, P.C. representative, typical for all recommended emergency repairs.

In the attached Figure 1 in Attachment 3, we have shown recommended emergency repairs. The purpose of the emergency repairs is primarily to fill the depressions and stabilize the left abutment. These repairs were initially discussed in the meeting between the Town, Schnabel, and Morgan Corp. on September 28, 2024, and have subsequently been modified based on additional site observations and material availability. Verbal authorization was given by the North Carolina Department of Environmental Quality (NCDEQ) Dam Safety to proceed with emergency repairs as necessary based on recommended repairs to be determined by Schnabel and communicated to NCDEQ Dam Safety as soon as possible upon design development. This verbal authorization was provided during a call between the Town (Dean Lindsey and Olivia Stewman), Schnabel (Jonathan Pittman and Charles Johnson), and NCDEQ (Toby Vinson) on the evening of September 27, 2024, after the onsite team provided an update to NCDEQ Dam Safety on the observed damage and site conditions at that time.

1. Cut and remove trees at top of slope and within the slide where can be safely performed.
2. Remove loose materials from the slide using a long-reach excavator or similar equipment.
3. Additional investigation and repairs are expected, but are still being evaluated. Slide area was filled with a graded filter consisting of ASTM C33 sand, NCDOT 78M stone, NCDOT 57 stone, and NCDOT Class B riprap.

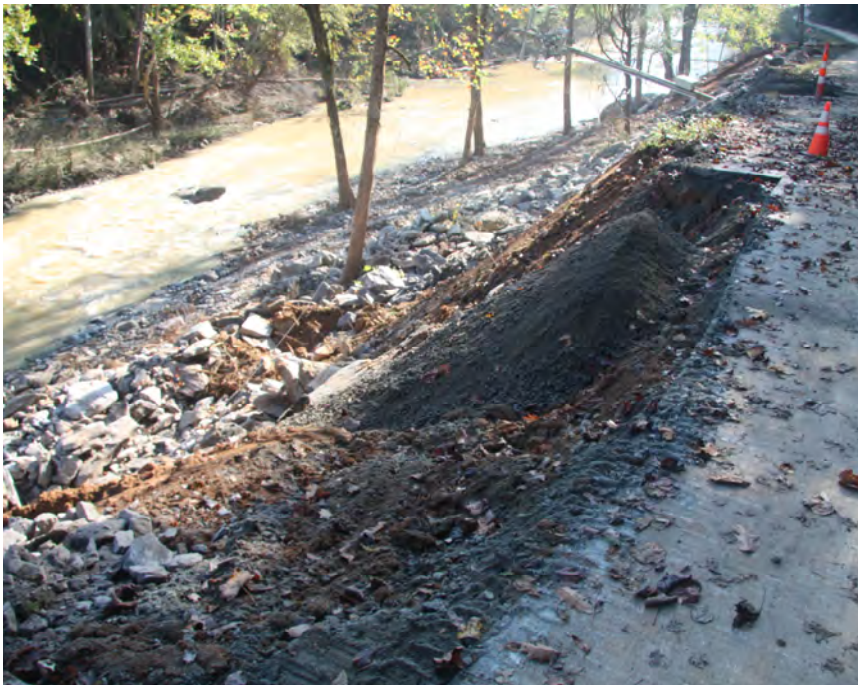
**Photograph: 4.4**

Undermined road asphalt concrete removed and slope backfilled.

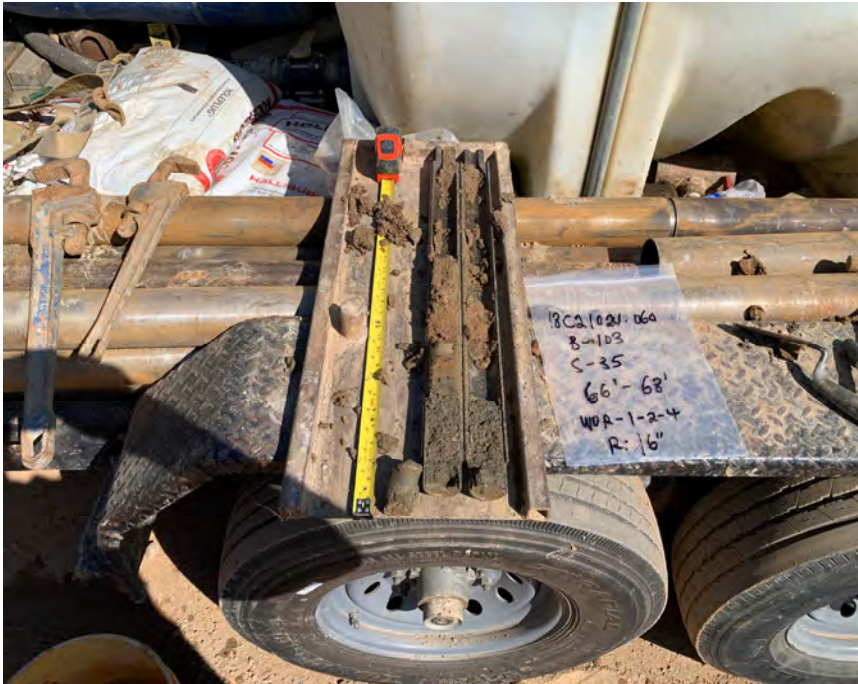
**Photograph: 4.7**

Soft material from depth of 66 to 68 feet below top of hole.

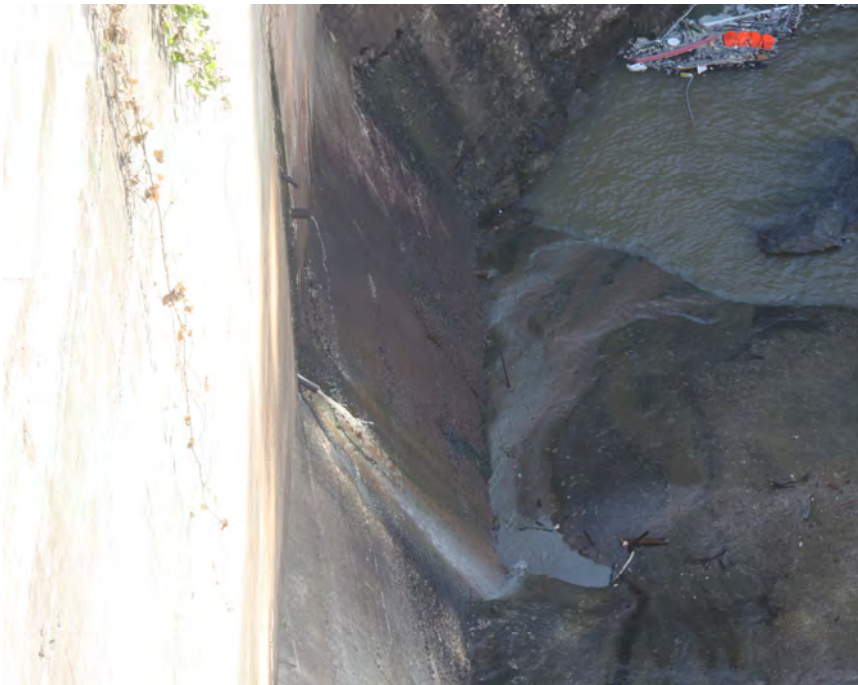
**Photograph: 4.8**

Grout discharge through left sidewall drain during backfill grouting of boring B103.

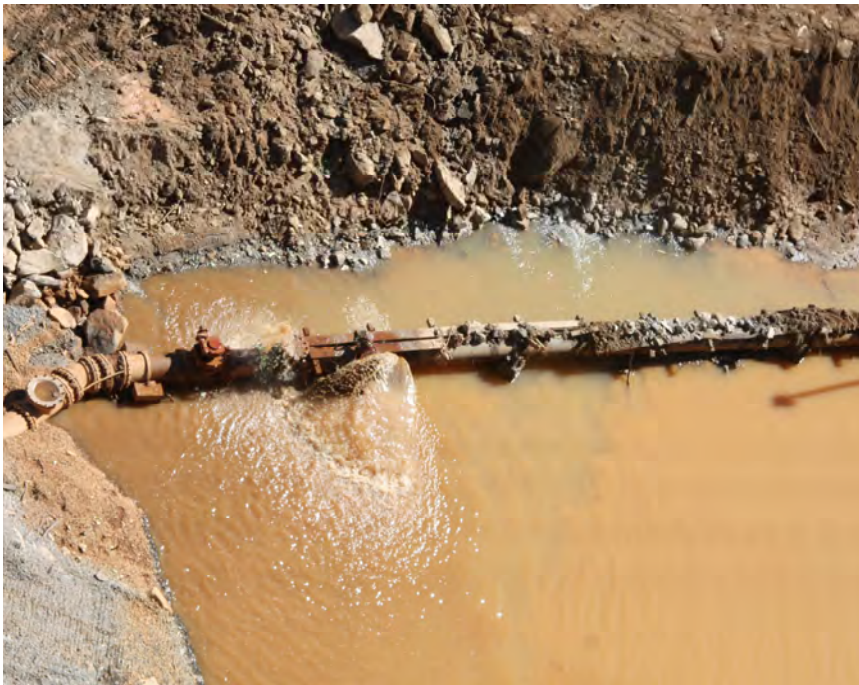
**Photograph: 4.16**

Sewer pipe leakage at stream crossing.
