## Lake Lure Dam

Independent Consultant  
Dam Safety Inspection  
*November 2006*

Town of Lake Lure  
North Carolina

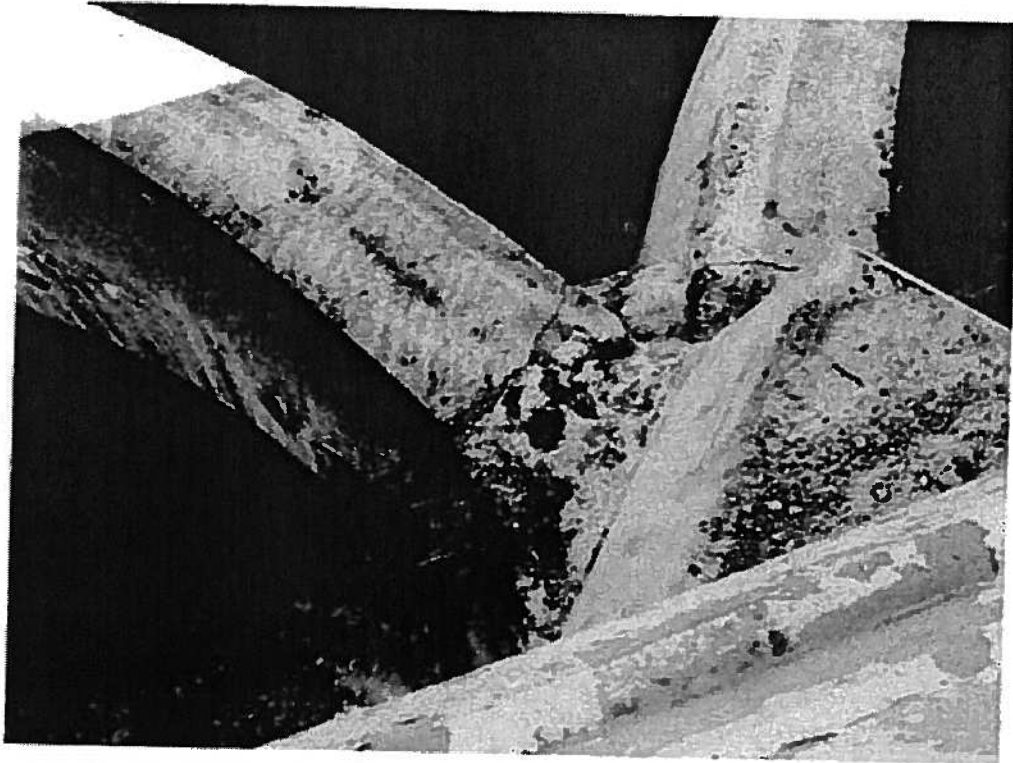
**Photograph 5 Arch/Buttress Interface**

Analyses of structures similar to Lake Lure Dam have verified that tensile stresses are negligible for static loading cases. The amount of reinforcing is not known (no drawings found) but the lack of cracking typical in unreinforced concrete suggest that at least temperature reinforcing was utilized. Cracks at the arch/buttruss interface suggest that a structural connection exist at that location.

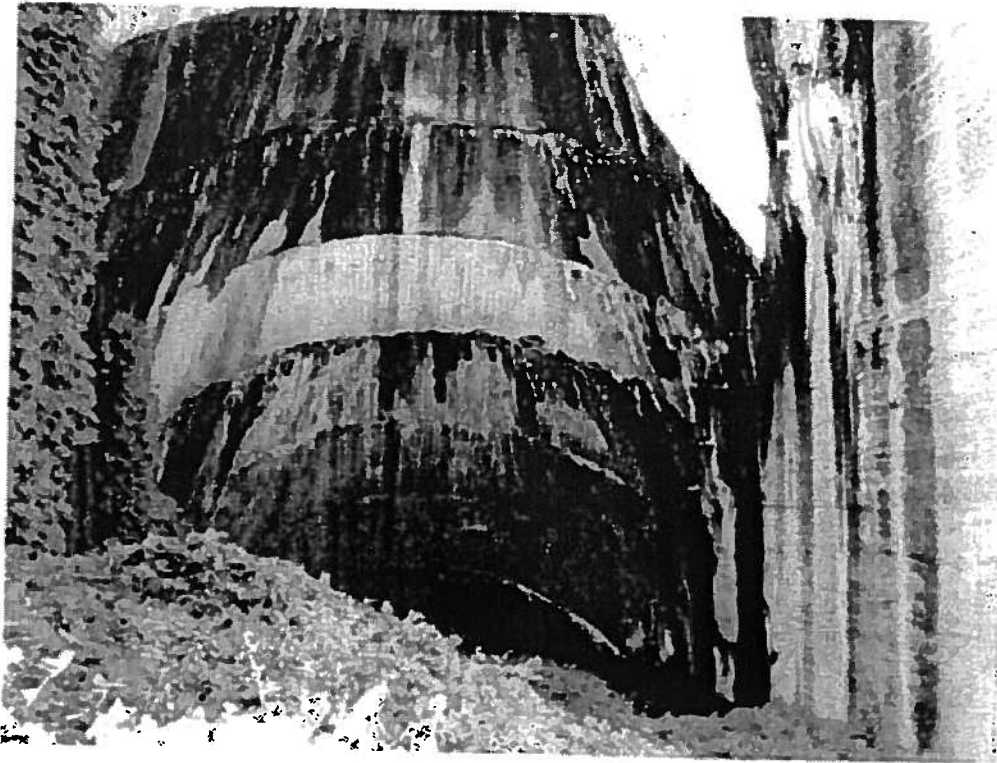
**Photograph 9 Typical Arch Barrel (Bay)**

Arch bays located to the right of the powerhouse were inspected by entering each bay from the downstream side. Minor leakage and efflorescence was observed at the lift lines (horizontal boundaries between successive concrete pours) and at the base of the arch. Reportedly, leakage does not vary significantly with seasonal changes in air and water temperature. Portions of the arch concrete was obscured by vegetation (Photograph 15) and the arch bays located to the left of the powerhouse could only be observed from the bridge deck, left abutment slope and from a significant distance downstream. There were no observed instances of structural distress such as severe cracking, deformation or misalignment. Cracking is present at the top of the arch/buttness interface (Photograph 5). At a number of locations, spalled concrete is exposing steel that may be reinforcing steel as well as additional steel associated with supporting original formwork.
